BRIDGE FATIGUE LIFE INDICATING SYSTEM

September 1991

Final Report
Contract No. DAAK70-91-C-0003

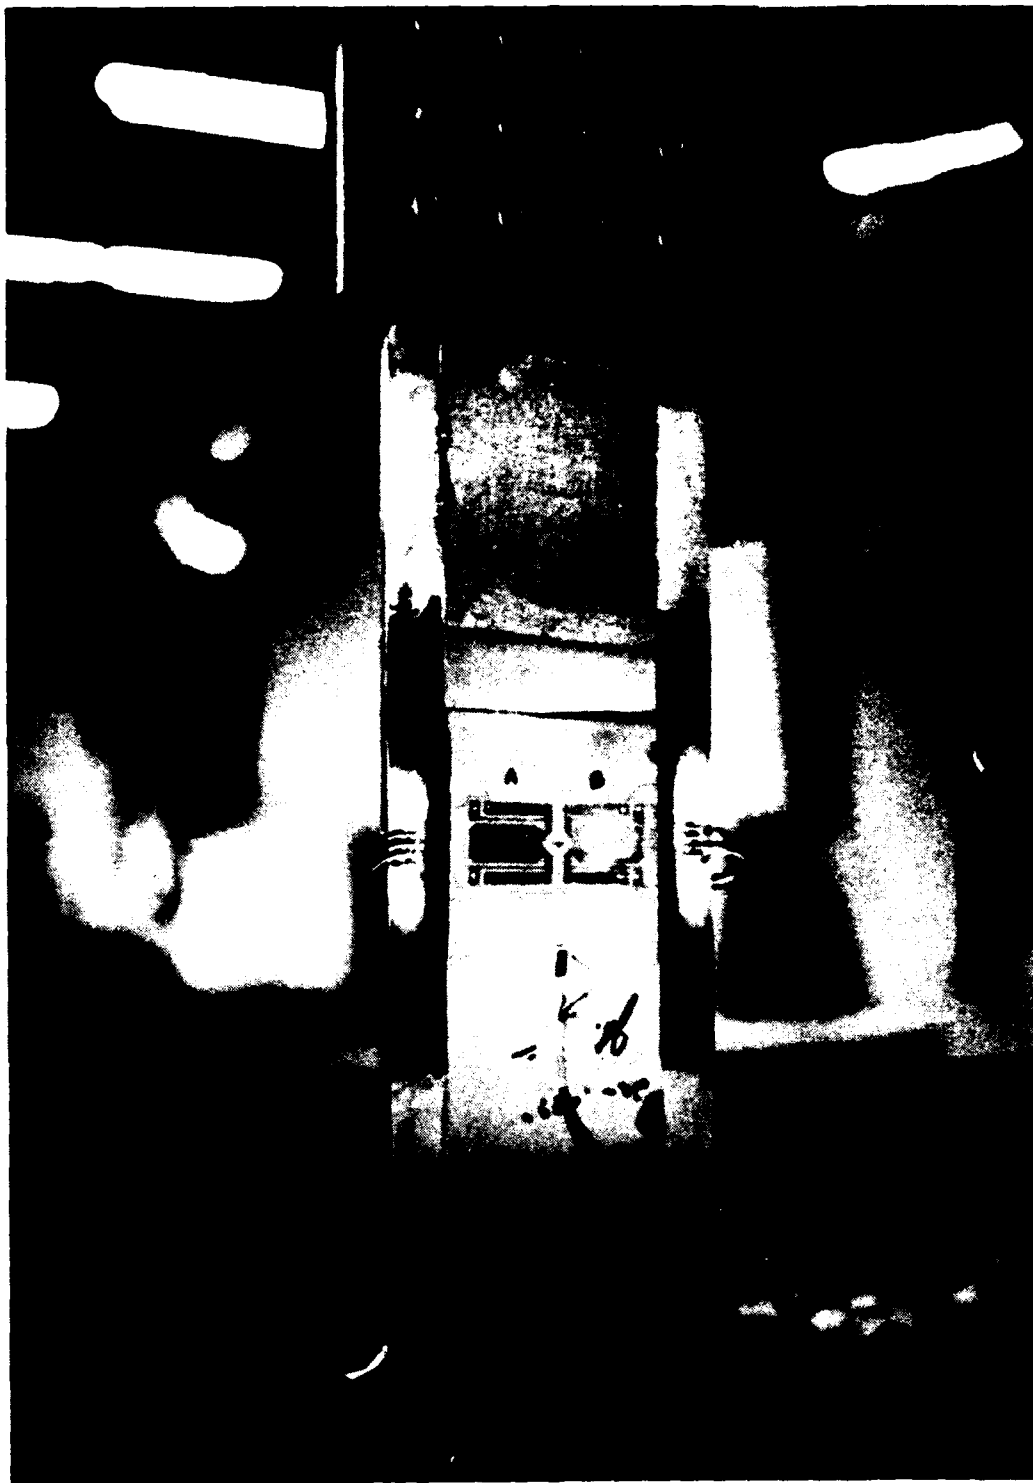
Figure 10. Full-Scale Bonding Test

Full-scale bonding tests were conducted using an assembly similar to that used with the bolted connections in Phase I of this program. This assembly, shown in Figure 10, consisted of a 0.25 in. thick parent coupon made from 7075-T6 Aluminum and two 0.04 in. thick precracked FLI coupons made from 2024-T3 and 6061-T6 Aluminum. The test coupons were bonded to the parent coupon at the areas indicated in Figure 11. All bonded surfaces were prepared using the same procedure defined for the preliminary bonding tests. Tra-Bond 2143D epoxy, cured for 4 hr at 160°F under heat lamps, was used for all test assemblies. Two Krak-Gages were bonded to each of the FLI coupons to evaluate their performance, as discussed in detail in Section 5.3.

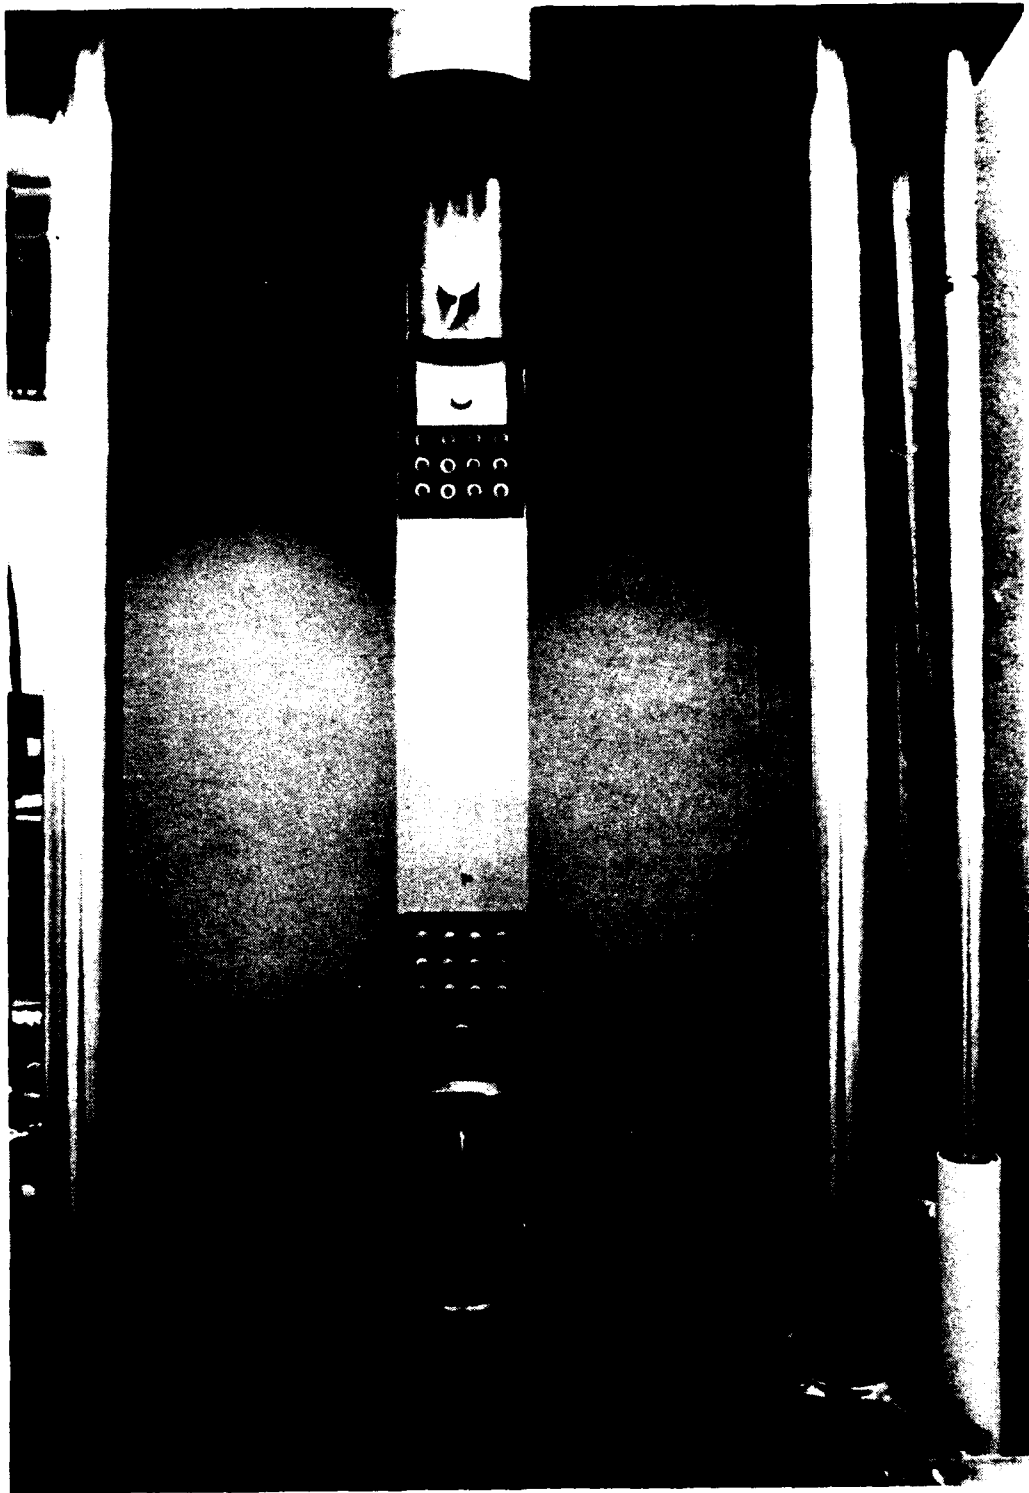
Figure 13. Ladder Gauge Test Setup

A total of seven tests were performed on the two different ladder gauges. The gauges were mounted on FLI coupons which were load cycled on an Instron 8502 tensile test machine. The load was introduced directly to the coupon with no parent structure, as shown in Figure 13. Stress cycles of 20 Ksi were applied at a frequency of 1 Hz.
